FIRE SAFETY INSPECTION REPORT

Occupant Name:	Heron Pond	Inspection Date:	6/14/2023
Address:	8407 Southwest 5 Street	Inspected By:	Victor Santos
Suite:	Bldg. - #11	Property Use Type:	Multifamily dwelling
Occupant Number:		InspectionType:	Work without Permits
Occ. Sq. Ft.:	20000	Number of AEDs:	0

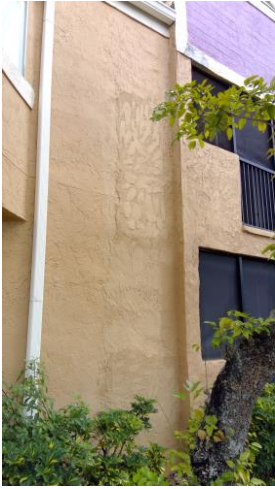
1.1 - 1.7.12.1.

Deficiency	FL NFPA 01 2018 ADMINISTRATION	1.7.12.1 - Work W/O Permits COPP Sec. 155.388 (see photo 1.1, 1.2, 1.3, 1.4, 1.5, 1.6, 1.7, 1.8, 1.9)
-------------------	-----------------------------------	---

Inspector Comments: Work has been conducted without permits that is concealing structural damage and without permission from the city's building department. Authorization for work will need to be obtained through the appropriate permitting and application process. Work includes plywood, stucco, and paint in areas previously noted to have compromised structural members. All current and future covering of these areas must stop until an approved method is conducted through the previously mentioned approval process.
